# **INDOOR AIR QUALITY ASSESSMENT**

**Undermountain Elementary School  
491 Berkshire School Road  
Sheffield, Massachusetts**

Prepared by:  
Massachusetts Department of Public Health  
Bureau of Environmental Health Assessment  
March, 2001

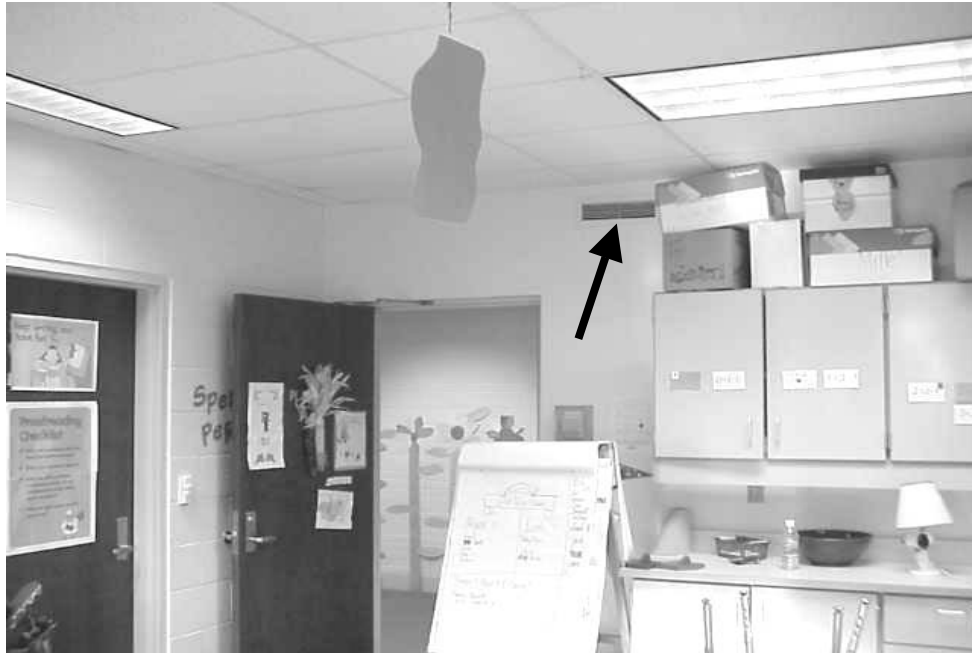
**Picture 2**

Exhaust ventilation in classrooms is provided by a mechanical exhaust system. The exhaust vents are located along interior hallway walls of classrooms (see Picture 2). In some cases, classroom exhaust vents are located above wall-mounted cabinets. In one instance, the exhaust vent was blocked with a box stored on top of a cabinet. In order to function properly, exhaust vents must also remain clear of obstructions.

**Classroom Exhaust Vent**

1. Remove materials blocking univents and exhaust vents.
2. Examine univents throughout the school for function. Survey classrooms for air diffuser and exhaust vent function to ascertain if an adequate air supply exists for each room. Check fresh air intakes for repair and increase the percentage of fresh air intake if necessary.
3. Ensure that ground level fresh air intakes remain clear of blockages, particularly snow in winter. Avoid grass cutting during school hours.
4. Examine the filters in the univents and AHU and change these filters on a regular basis. Consider increasing the dust spot efficiency of filters to increase the removal of particulates from the environment.
5. Once fresh air supply and exhaust systems are functioning, consider having the systems balanced by a ventilation engineer.

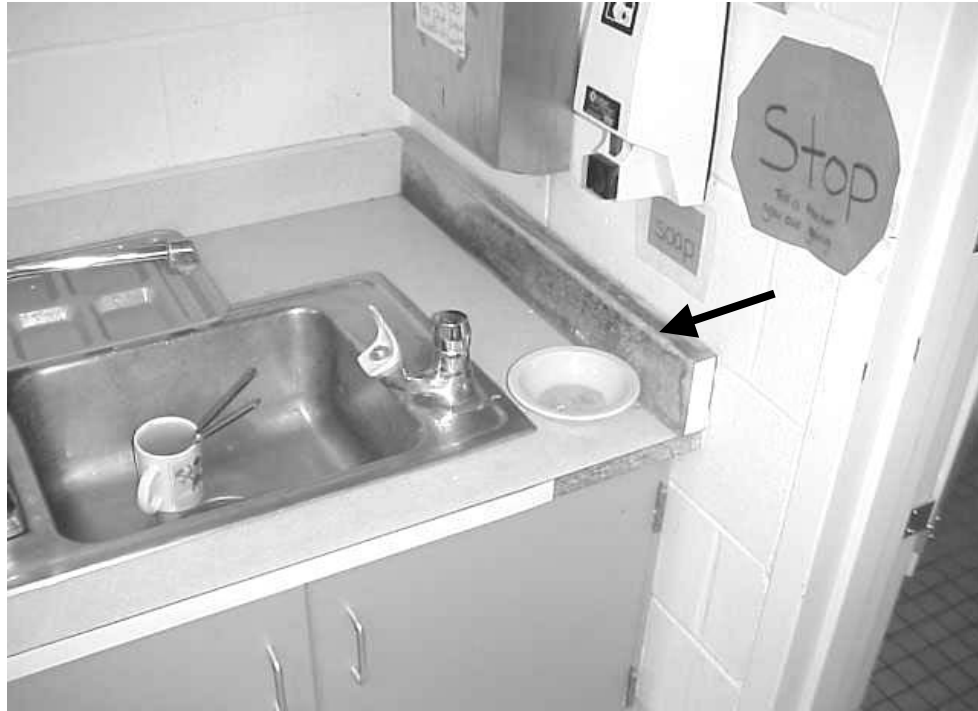
**Picture 3**

In a number of classrooms, spaces between the sink countertop and back splash were noted. Water damage resulting in splaying of wood of sink areas was also noted (see Pictures 3 and 4). Repeated leakage or improper drainage/overflow can lead to water penetration of countertop wood, the cabinet interior and behind cabinets. If these porous materials become wet repeatedly they can provide a medium for mold growth. The American Conference of Governmental Industrial Hygienists (ACGIH) recommends that porous materials be dried with fans and heating within 24 hours of becoming wet (ACGIH, 1989). Porous materials that are not dried within this time frame may provide for mold growth.

**Water Damaged Sink Countertop**

6. Examine each sink counter top for water damage. Seal the back splash/countertop seam with caulking to reduce water penetration. Examine the floor below the water-damaged wood for mold growth. If mold is present, disinfect any non-porous surfaces with an appropriate antimicrobial agent and subsequently clean with soap and water.

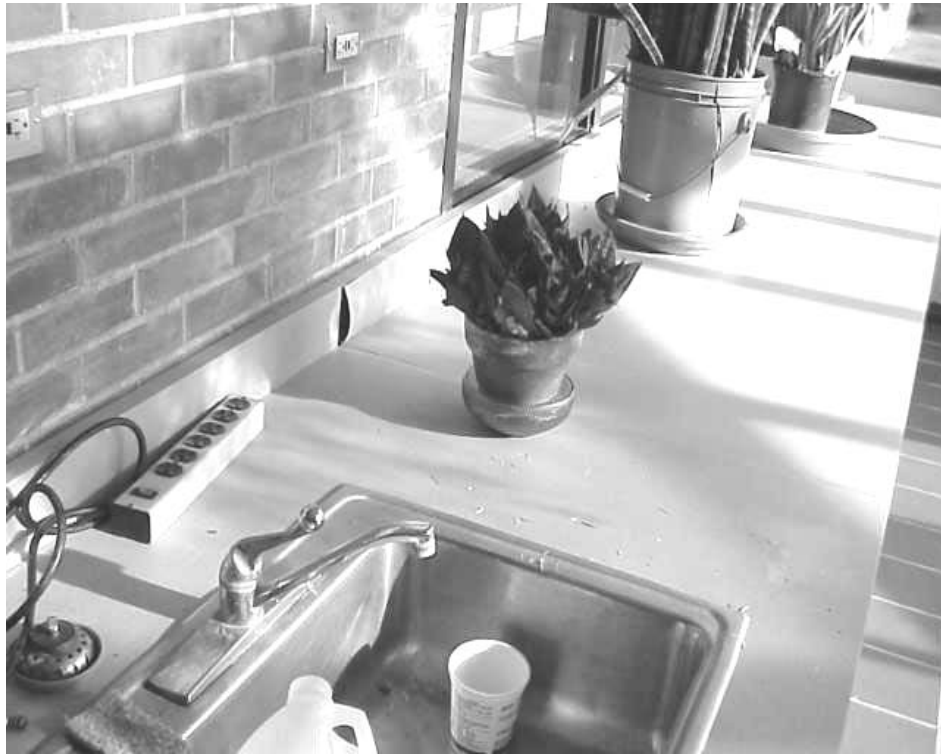
**Picture 4**

**Bowing Countertop Linoleum in Greenhouse**

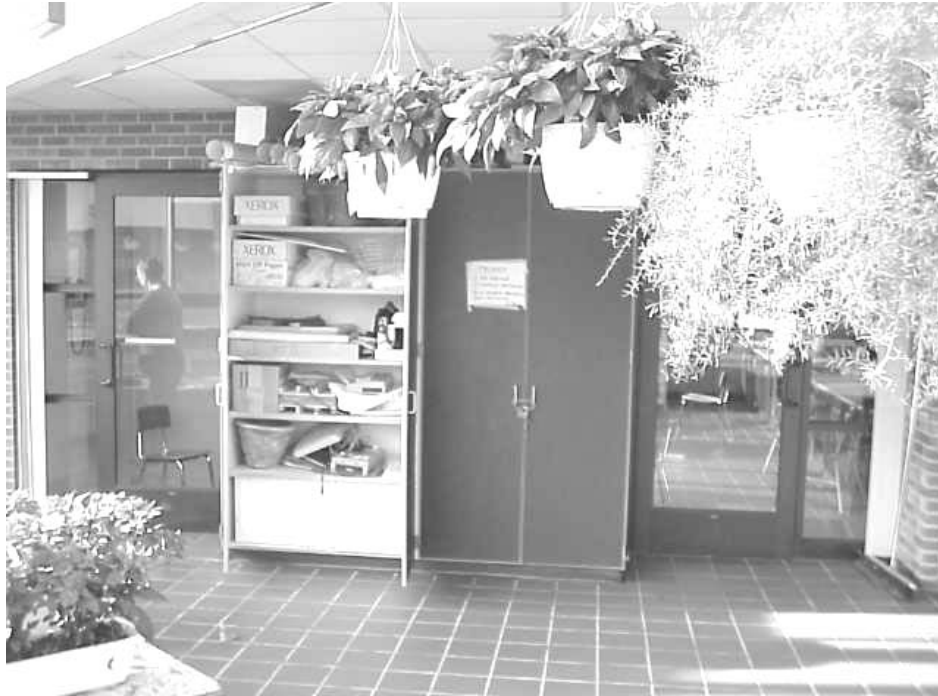
**Picture 5**

The greenhouse is designed to retain heat and moisture to aid the growing of plants. This room would have a higher relative humidity than other areas in the building. With

increased exposure to moisture, porous materials (e.g., cardboard, wood, paper, ceiling tiles and cloth) can serve as potential media for mold growth (see Picture 5). Standing water was noted on top of a wooden table (see Picture 6). The use or storage of porous materials within the greenhouse should be avoided where possible to limit mold growth.

**Cardboard and Other Porous Materials Stored in Greenhouse**

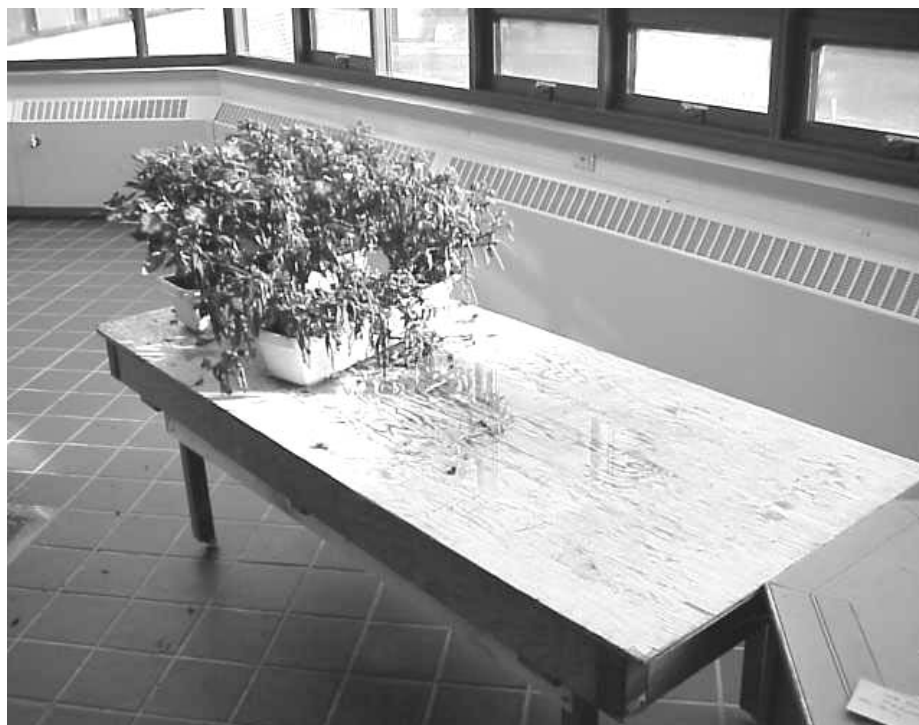
**Picture 6**

**Standing Water on Table in Greenhouse**

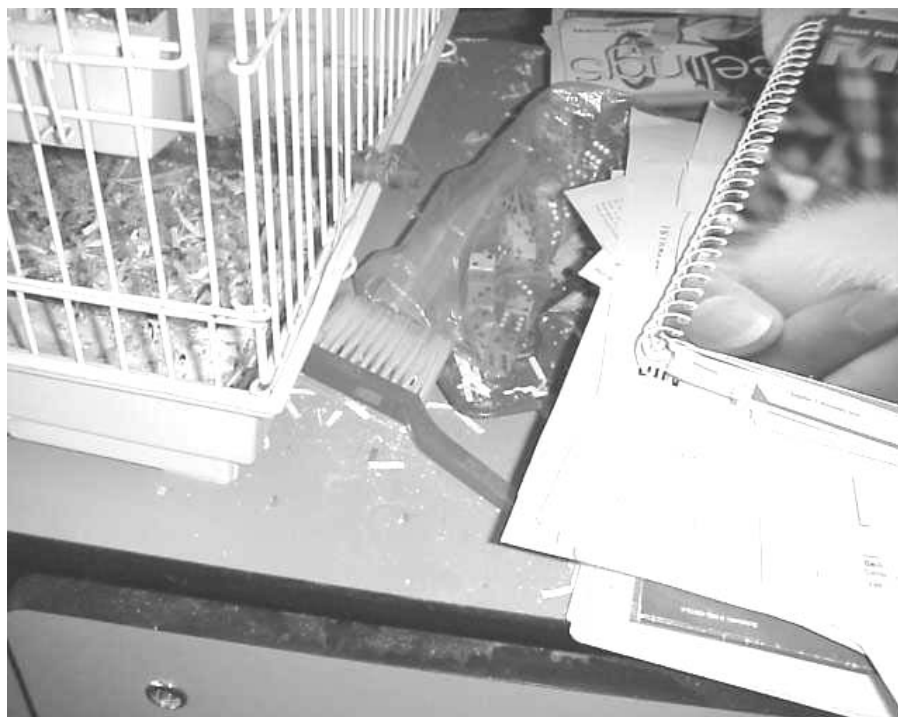
**Picture 7**

Classroom A4 contains several birds and rabbits. Debris from the interior of the bird cages was noted on tables (see Picture 7). Bird waste can contain a number of materials that are allergens. Rabbit dander, fur and wastes may also be allergenic to hypersensitive individuals. If animals are to be kept in classrooms, it is good practice to remove animal waste from cages frequently. In addition, cages of animals should be kept away from the air stream created during the operation of univents to limit aerosolization.

**Bird Cage Debris on Counter Outside of Cage**

9. Move animal cages away from univents. Clean cage materials from tables and disinfect tables with an appropriate antimicrobial agent daily. Clean nesting materials from the interior of cages frequently.

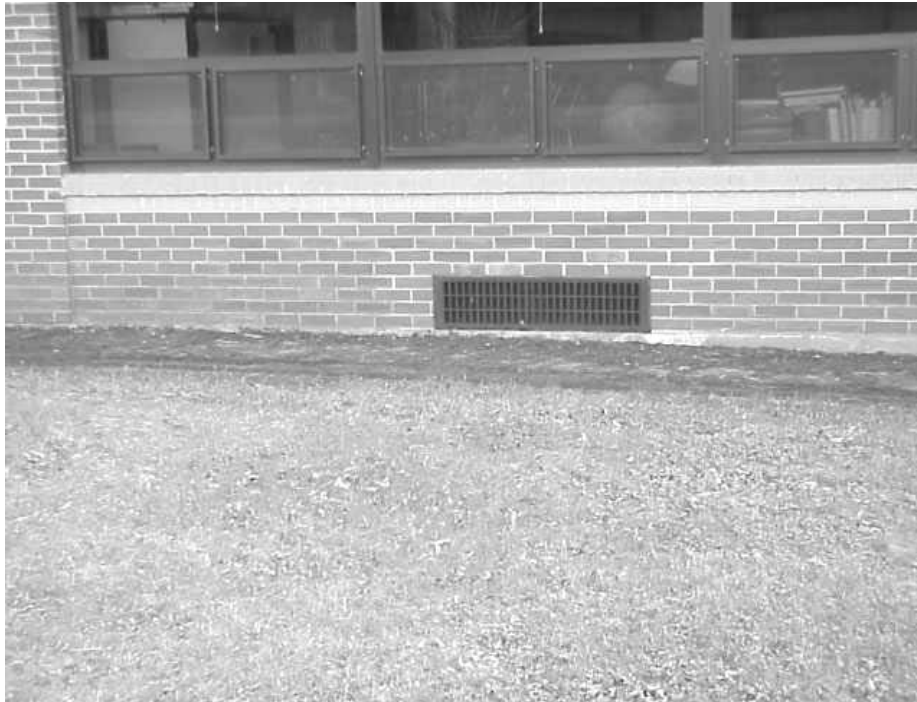
**Picture 8**

Some univent fresh air intakes are located at ground level (see Picture 8). These vents can be prone to drawing dust, dirt and pollen into univents. For this reason, grass cutting during school hours can present problems. They can also become blocked with accumulated snow.

**Univent Fresh Air Intakes Located Close to the Ground**
